**WEBSTER CITY – ADA TRANSITION PLAN
2023 Update**

Webster City, Iowa | November 28, 2023

1. EXECUTIVE SUMMARY

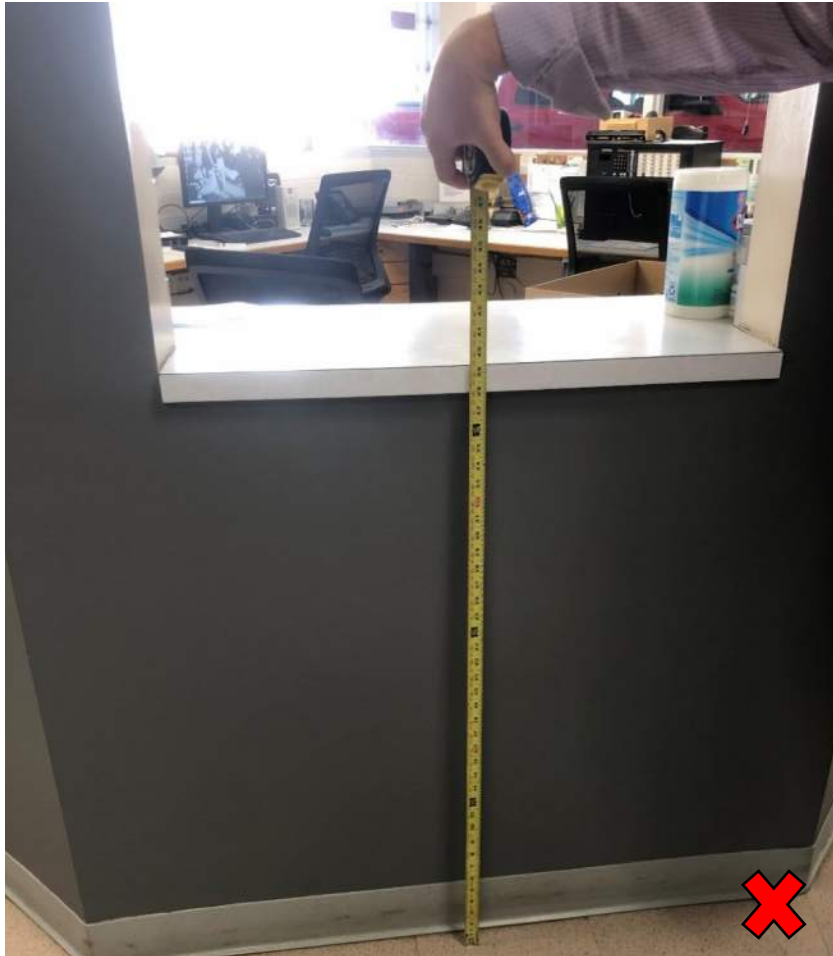
Service Counter

- The service counter is too high, shallow, and narrow for wheelchair access.

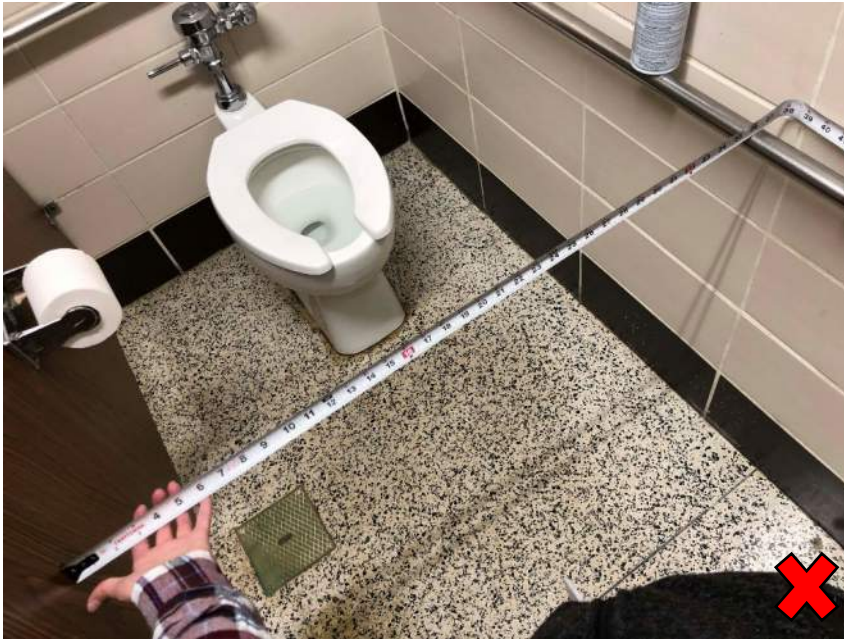
Restroom – Stall Width

- The stall is too narrow for wheelchair access.

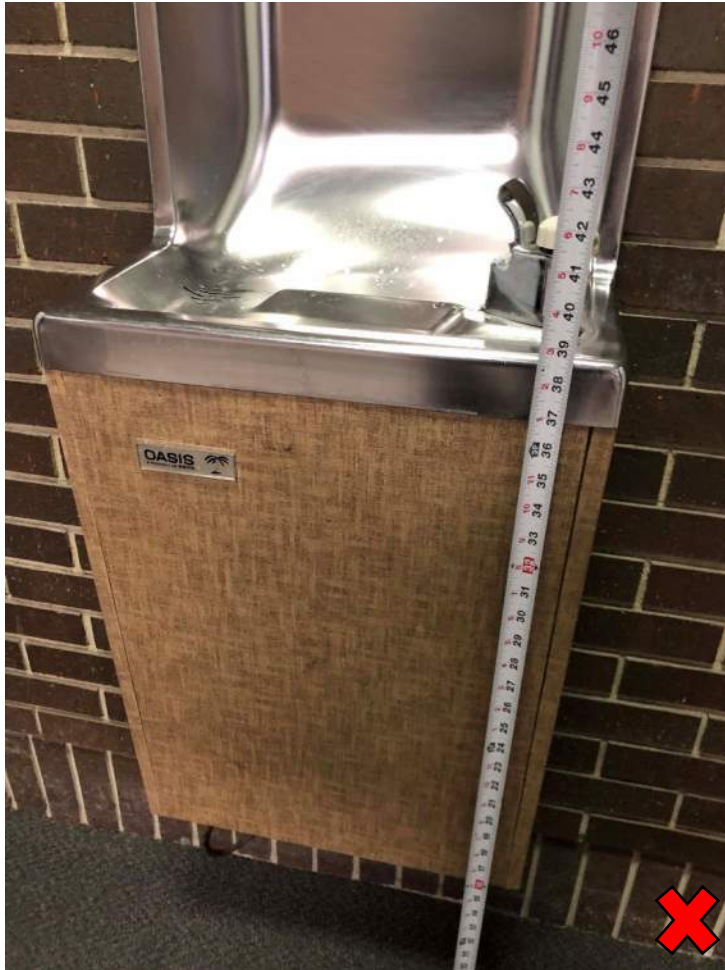
Height of Drinking Fountain

- The drinking fountain lacks clear space for a wheelchair user's legs.
- The waterspout is too high above the floor.

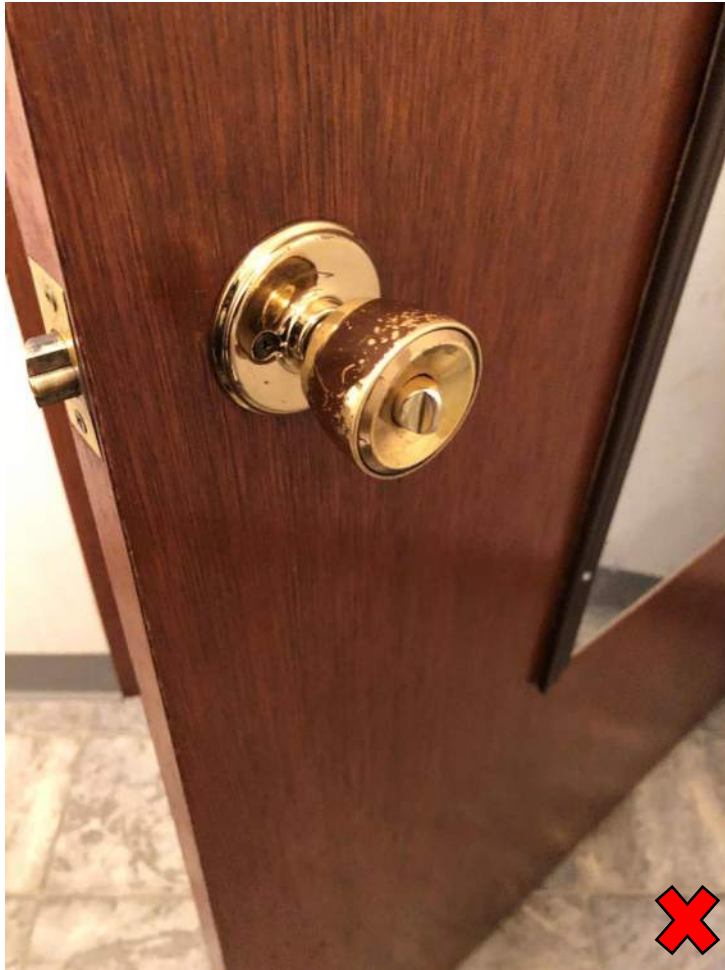
Door Knob vs
Door Handle

- Handles requiring tight pinching, grasping, or twisting of the wrist are not considered accessible.
 - This handle requires grasping and twisting.
 - This lock requires pinching and twisting.

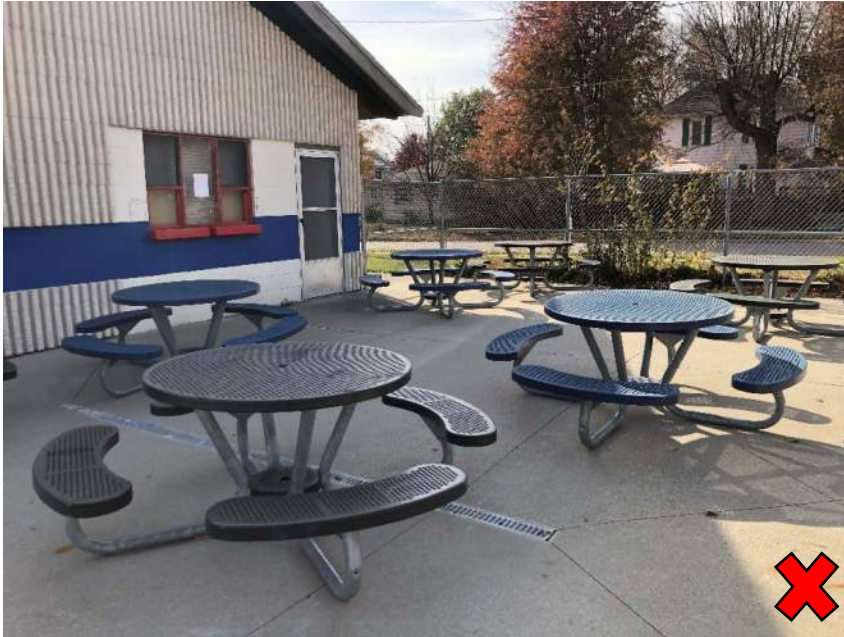
Food Service Areas

- None of the tables are accessible for wheelchair users.
- The concessions service counter is too high, shallow, and narrow for wheelchair access.
