**WEBSTER CITY – ADA TRANSITION PLAN
2023 Update**

Webster City, Iowa | November 28, 2023

1. EXECUTIVE SUMMARY

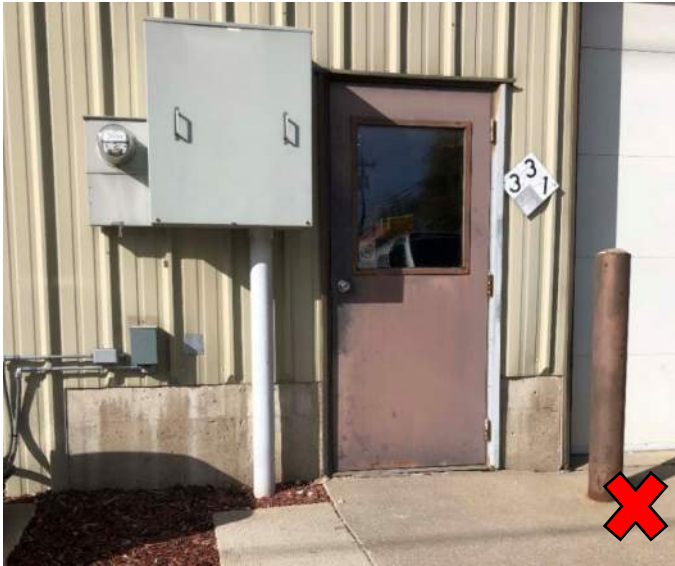
- Door lacks clear space on the latch side for wheelchair maneuvering.
- Ground in front of door is too inclined.
- Handle requires tight grasping and twisting of the wrist.
